TU BERGAKADEMIE FREIBERG
 Geotechnical Institute
 Chair for Rock Mechanics
 Gustav Zeuner Str. 1 • 09596 Freiberg
 Tel./Fax. +49 3731 - 39 2519 / -3638
 www.tu-freiberg.de/fakult3/gt

Small sized monuments: Development of non-destructive methods for consolidation

Study case for full consolidation

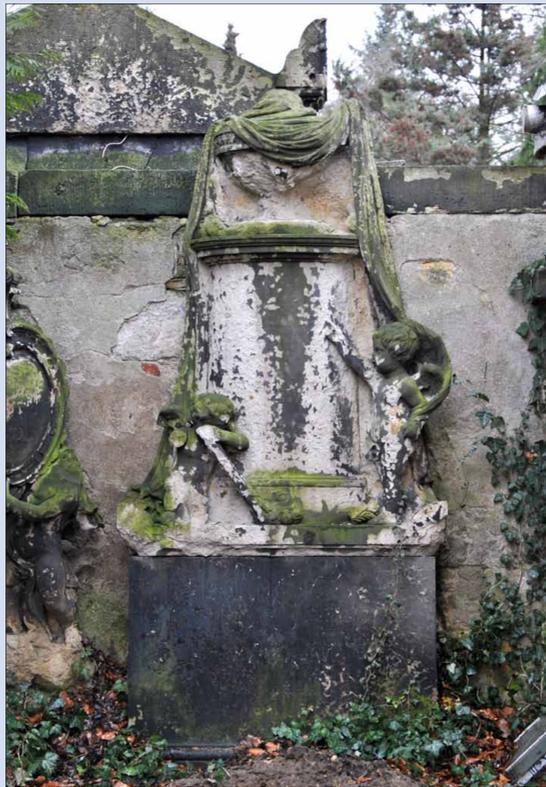
The baroque tombstone was erected in 1763 in Elbesandstone material of Cotta-type. Two putti, three cartouches for inscriptions and two heads of angels within a gloriole are shown.

All elements undergo heavy soiling and sanding. Green algae and black crust formation are visible on the remaining original surface while rain shielded areas suffer beginning alveolisation.

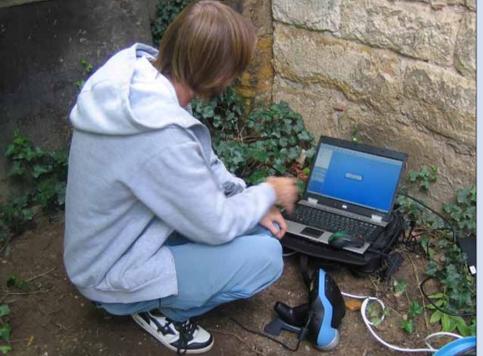
Generation of a 3D-surface by means of a handheld laser scanner and the software Geomagic®

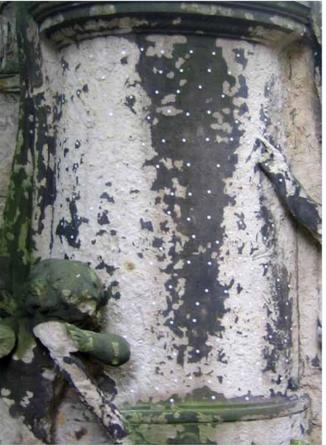
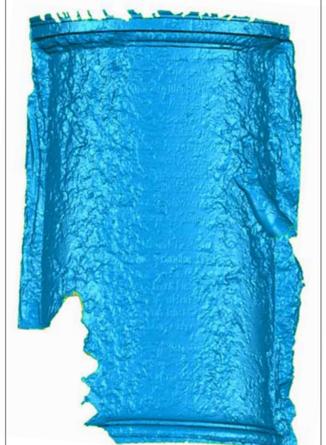
tombstone after consolidation: Relocation to a new appropriate place. The surface became more darkly and lost its original yellowish colour due to the consolidant. After the exhalation it hopefully turns into a brighter more yellowish appearance.
